Firmware change-log of new features and bug fixes of the u-remote modules:

UR20-1COM-232-485-422 (1315750000)

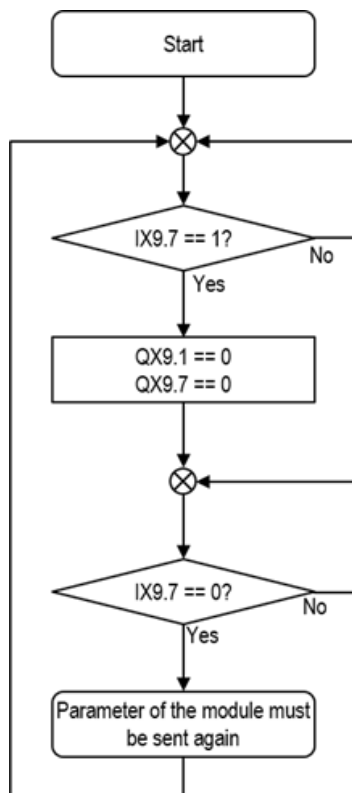
Non-simultaneous power cycling of external power supply and u-remote system supply while a motor is rotating could lead to unwanted motor movement:

- A power cycle at the external power supply while the u-remote system supply remains causes the motor to stop and restart after external power supply is restored. The motor will continue moving to the target position of the last move command before the power interruption.
- A power interruption of the u-remote system supply while the external power supply remains causes the motor to continue to rotate to the target position of the last move command.

The application program of the connected controller (PLC) should check the status of the process data bit "State power supply" (IX9.7). If the "State power supply" bit is "false" (0) the program should reset both the bit "Moving" (QX9.1) and the bit "Enable motor driver" (QX9.7) to "false" (0). (please see UR20 Stepper motor module manual)
