# Troubleshooting electrical problems in high-end TVs

Using logging and TrendCapture in the Fluke 289 DMM

## Application Note

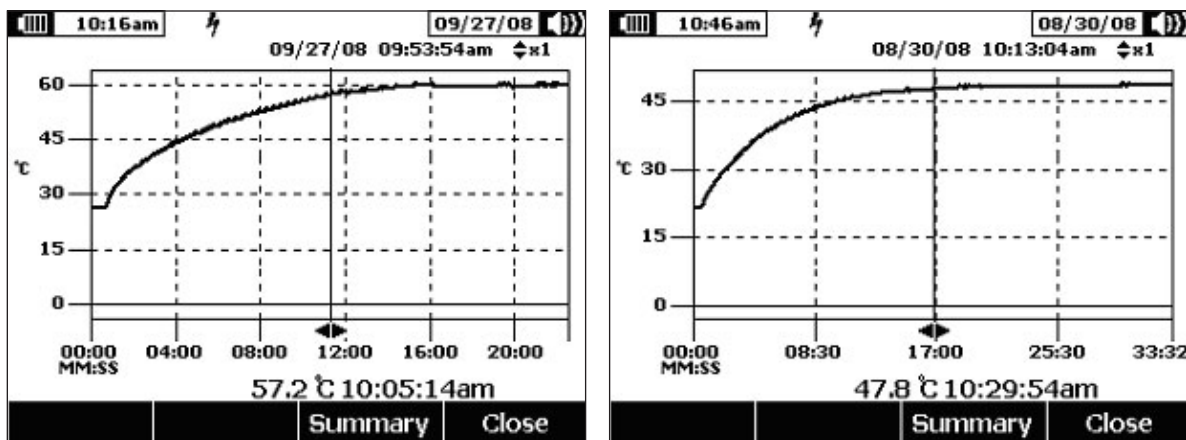
Figure 1. Left Screen Shot shows an amplifier that is running too hot. Right Screen Shot shows an amplifier running at normal temperature.

the heat sink). Set up the 289 DMM to record the temperature at ten second intervals and start recording. Turn on the TV and allow the set to warm up to its normal operating temperature, about 20 to 30 minutes. After about 15 minutes, the temperature should be around 45 °C to 55 °C. **Figure 1** shows the screen shots of the temperature recordings for a normal amplifier and an amplifier that is running too hot.

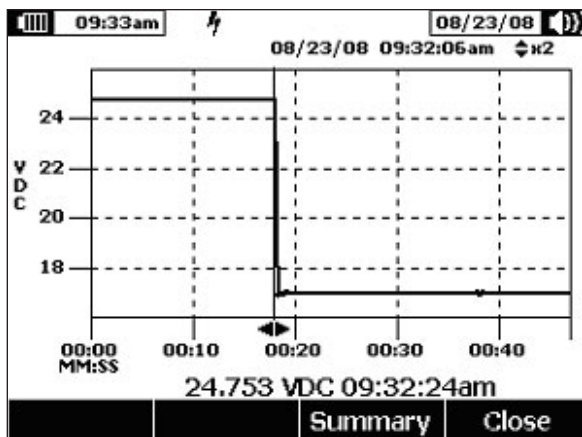
Figure 2. Screen shot showing the controller IC supply voltage as the supply is being turned on. Before the supply is enabled, the voltage is about 24.75 V and drops to approximately 17 V.

Using the 289 DMM, the problem was traced to the startup circuit where there was a defective electrolytic capacitor. The DMM was connected across the supply for the controller IC. When the controller IC was enabled, the supply would drop below the minimum supply voltage needed for the controller to operate. **Figure 2** is a screen shot of the supply voltage for the controller IC with the TV turned on. The screen shot is a recording made after the capacitor was replaced. Before the capacitor was replaced, the voltage dropped below 12 V, below the low supply threshold, shutting the IC down. The Zoom feature enables the technician to examine the voltage levels as the supply is being enabled and turned on.

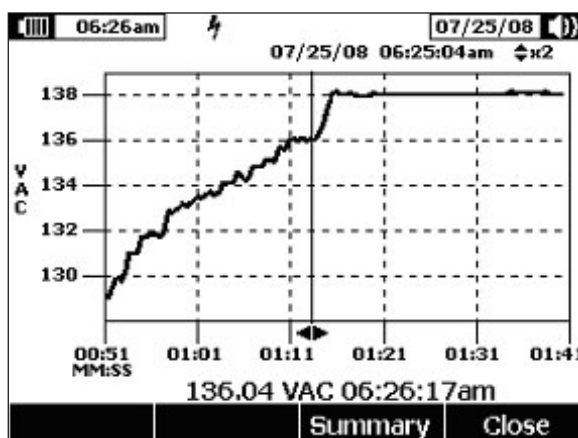
**Figure 3.** Screen shot showing the voltage level of 136 V where the TV shuts down.

After the TV shuts down or turns off, stop the recording and save the session. Select Trend and Zoom to observe when the line voltage jumps two to three volts within one or two seconds. The voltage at this point is the voltage level where the TV shuts down. **Figure 3** shows the transition point just as the TV shuts down at a line voltage of 132 V.

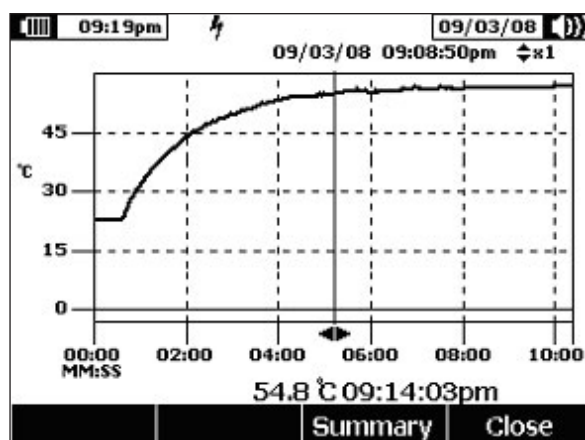
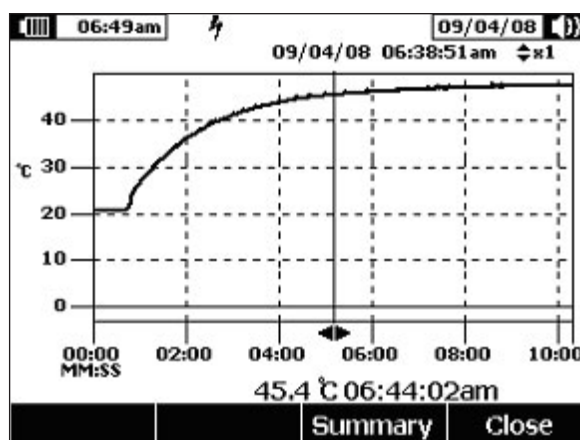
**Figure 4.** Screen shots showing temperature of 3-terminal regulator IC before capacitor replacement, left, and after capacitor replacement, right.

After about five minutes, the temperature of the metal tab was about 55 °C. The input voltage to the regulator was 14.5 V when it should be around 12 V. The output level of the switching supply is regulated by sensing the voltage level at the output of the control/sense circuit, which generates a voltage proportional to the

voltage across a sense winding of the power transformer. The problem was traced to a faulty capacitor. Once the capacitor had been replaced, the input voltage dropped to 12.03 V, and the temperature of the regulator dropped to 45.2 °C at five minutes and 46.9 °C at eight minutes. Screen shots of the temperature recordings are shown in **Figure 4**. The left screen is before the capacitor was replaced, and the right screen is after the capacitor was replaced.
